How has the _____ Port Radium Remediation Project made the site safer for people, animals, and the environment?

The Port Radium Site is a former uranium and silver mine located on a peninsula along the eastern shore of Great Bear Lake in the Northwest Territories, 440 kilometres north of Yellowknife and 265 kilometres east of the Dene community of Délı̨nę within the Sahtú Dene and Métis traditional lands. The site was decommissioned in 1982 to the standards of the day.

Remediation, completed in 2007/08, has made the site safer for people, animals and the environment.

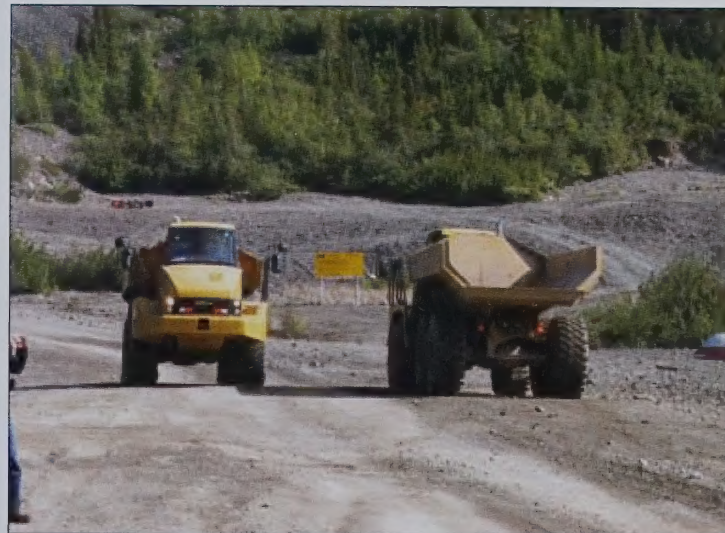
Remediation work at the Port Radium site, August 2007

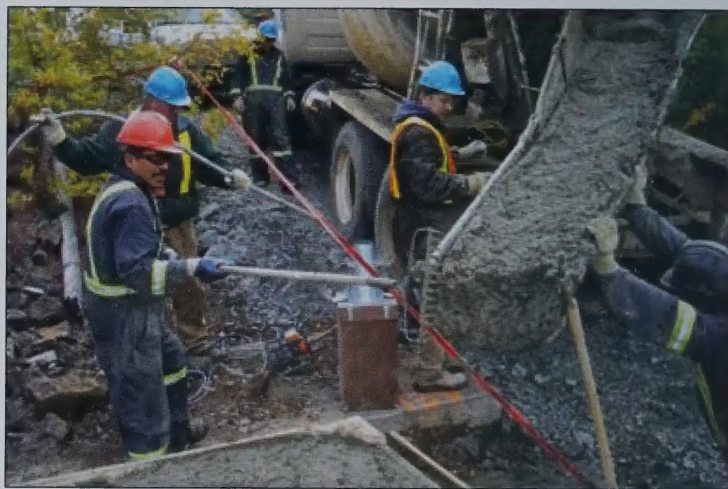
Pouring concrete to cap a mine opening, Port Radium, 2007

- Covering vertical mine openings with a concrete cap
- Filling in horizontal openings with rock. In areas where this was not possible, fencing was placed around the areas.
- Demolishing foundations of old buildings, and covering those level with surrounding area
- Removing the dock at Inner Labine Bay, and regrading
- Moving scrap metal to a landfill on site
- Demolishing old wooden structures on site such as the Cross Fault Lake head frame, wooden sheds, and cabins

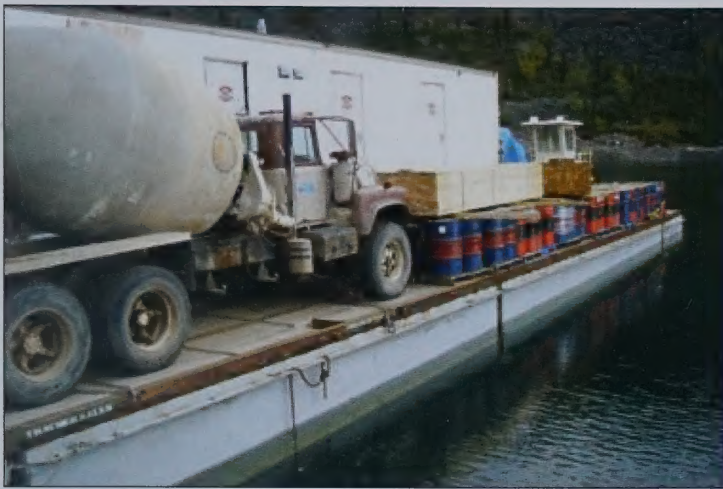
Barge with equipment and supplies for remediation work, Port Radium, 2007

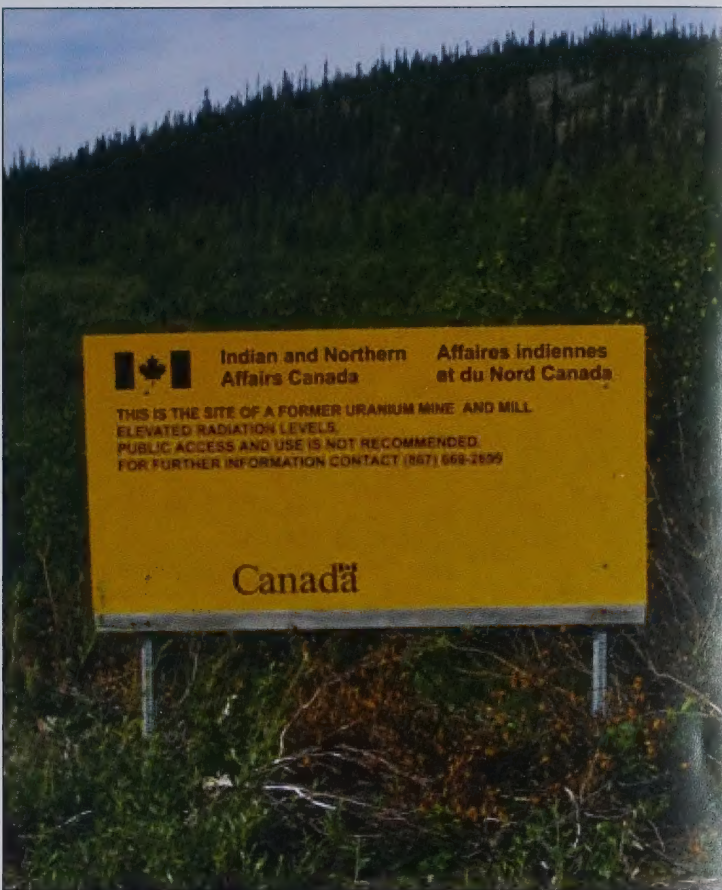
Sign at the Port Radium site, notifying visitors that the site is subject to a Waste Nuclear Substance License

In addition, the site is covered by a Waste Nuclear Substance license, from the Canadian Nuclear Safety Commission, and is being monitored by them forever. INAC must file reports every year with the Commission. Signs will remain posted at the site to let people know that access is restricted. Community members have been told of the site restrictions, as have others, such as industry and exploration companies operating in the area.

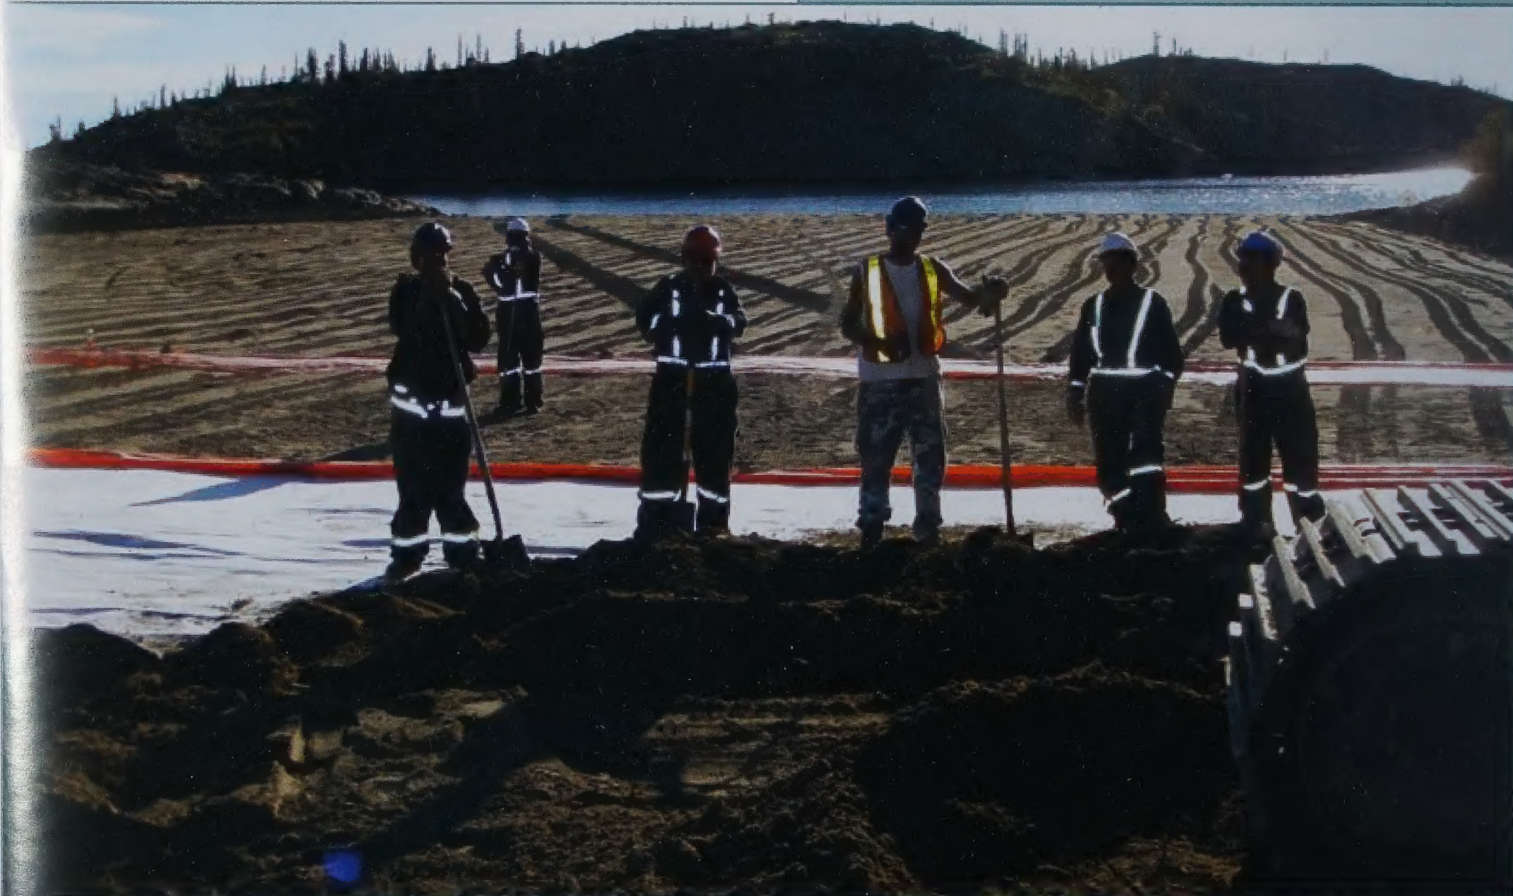
Workers laying the geotextile liner at the Silver Point Tailings Area, July, 2007

To fix the problem, the pools were filled in with clean tailings and native soils. A layer of geotextile liner was then placed over the entire tailings area to prevent water from entering the tailings. Then, the liner was covered with rock to protect it.

This rock-covered geotextile will keep rain and other moisture from getting to the tailings underneath, and keep heavy metals from flowing into Cobalt Channel.
